REPORT OF INVESTIGATION OF STRUCTURAL FAILURE

**Structure Name and Location:** Allen Dam, approximately 2 miles SW of  
Thatcher, Graham County, Arizona  
(Sec. 9, T7S, R25E, Gila and Salt River  
Meridian)

Allen Dam, Graham County, Arizona

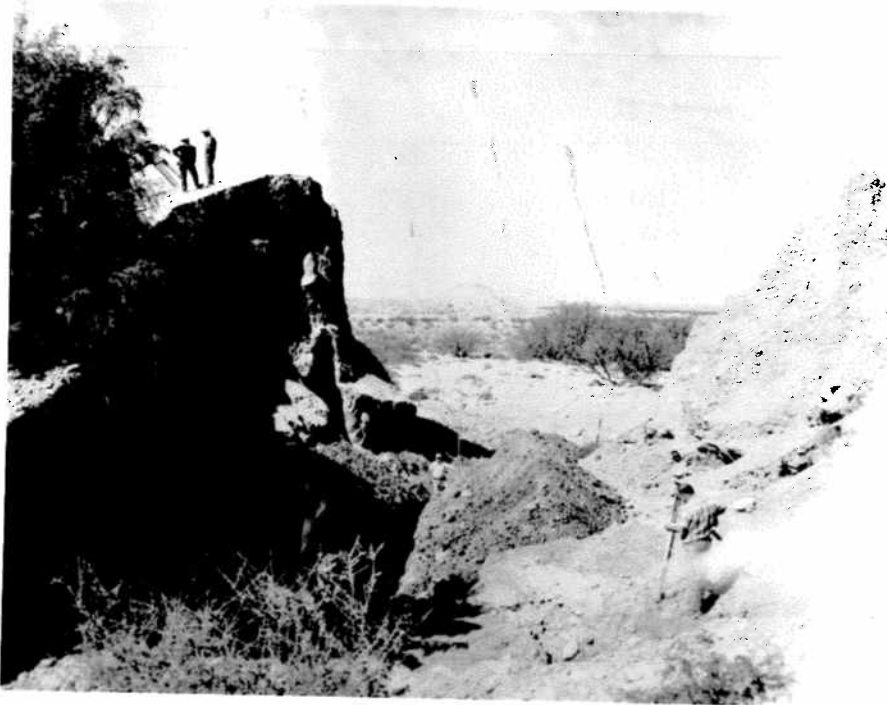
1. Looking northwest through washout - Sta. 2+50 $\pm$ .

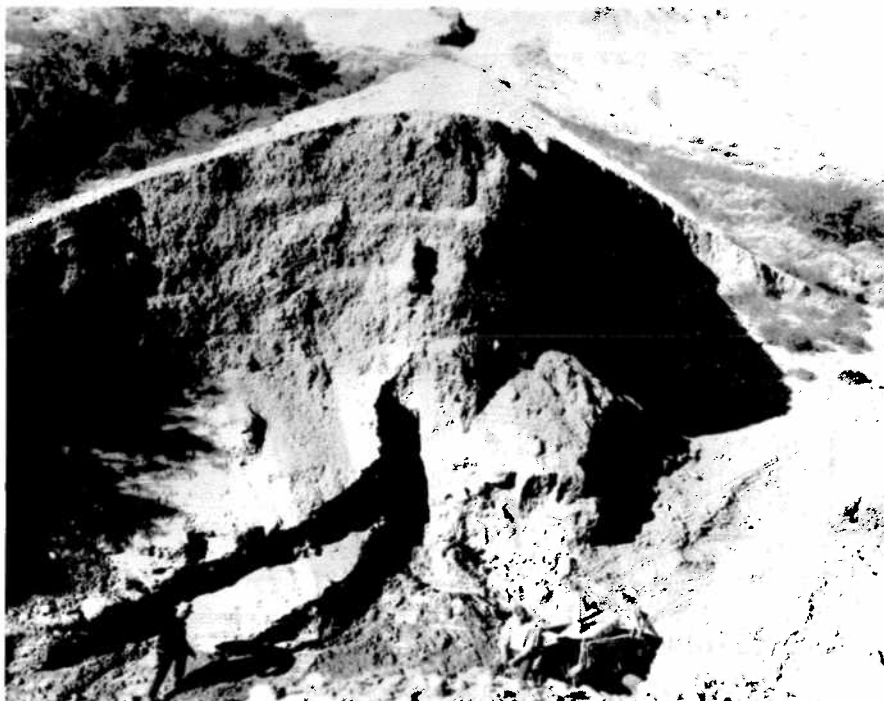
2. Looking west facing failure section Sta. 2+00 $\pm$ .

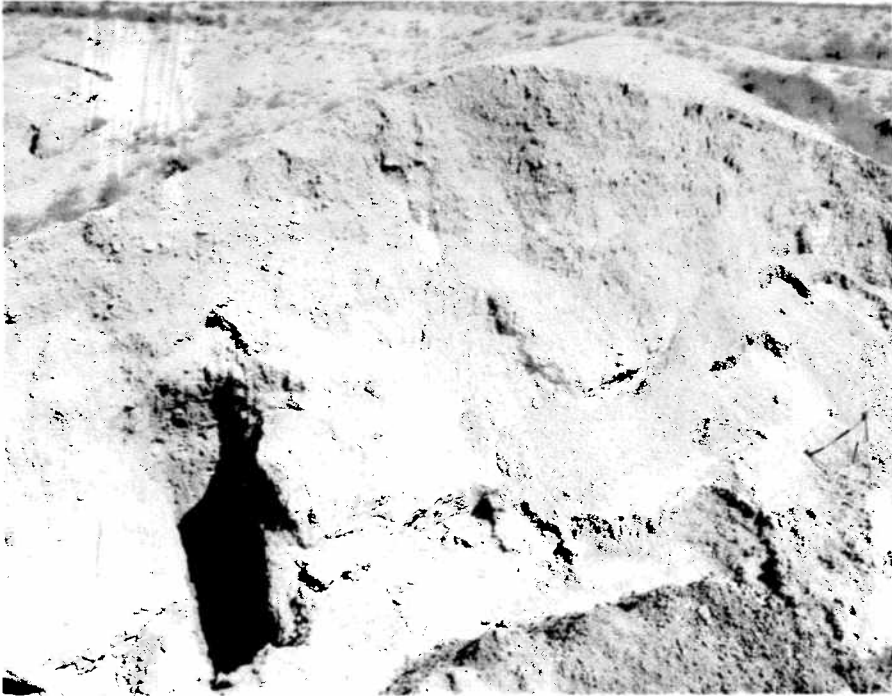
A backhoe pit was excavated in each face of the breach. The material excavated ranged from relatively clean gravels to quite plastic clays. (See photo #3). The moisture content varied from dry to approaching saturation. (See photo #8).

3. Looking east face Sta. 3+00±.

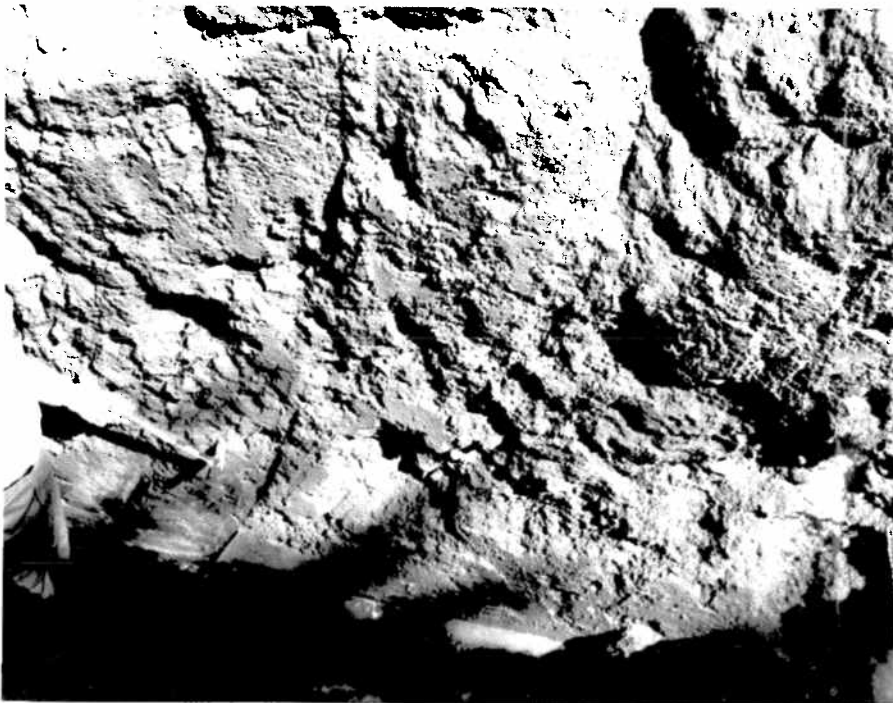
4. Foundation trench through failure section. Note contact of cutoff, gravel layer, and lake bed sediments.

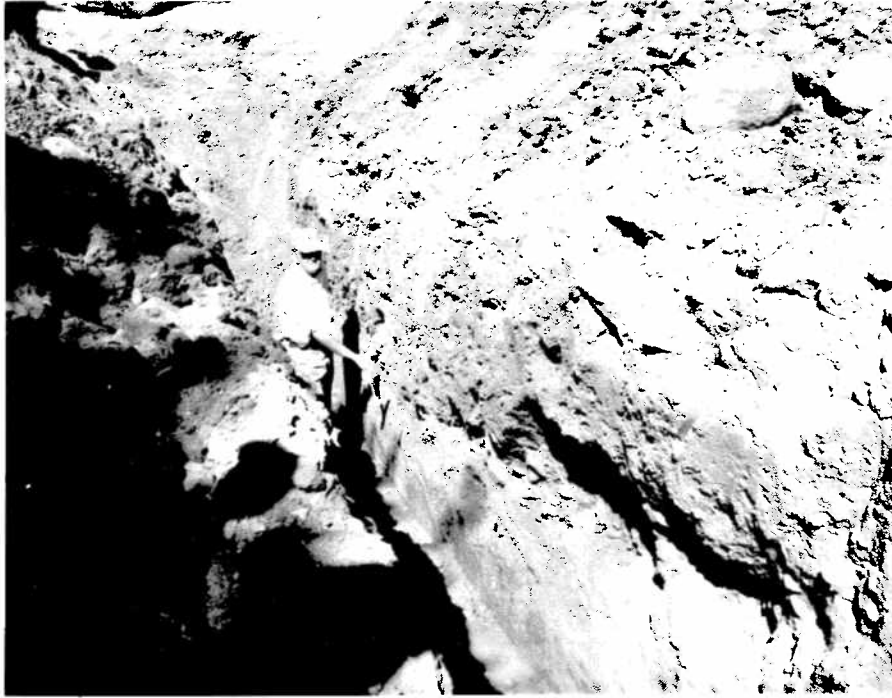
5. Foundation trench through failure section. Note base of cutoff by W. F. Mildner, Geologist.

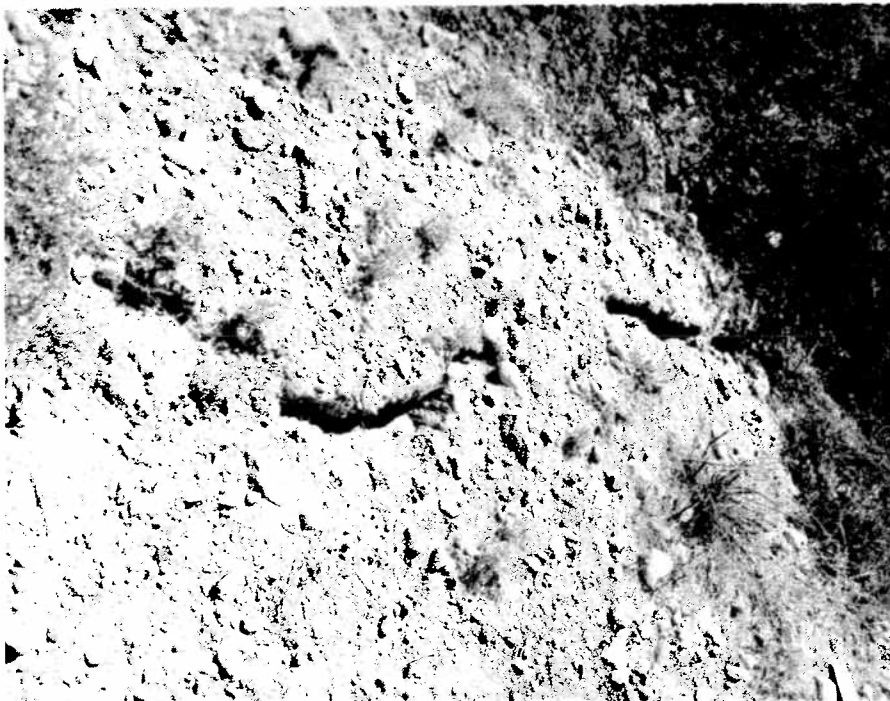
A longitudinal crack up to 3" or 4" in width was observed along the upstream face of the dam at about elevation 102. It started about 200 feet from the breach toward the left abutment and ran for about 40 feet. A backhoe pit was excavated across the crack. It went to a depth of about 3 feet. (See photos 6 and 7).

6. Longitudinal cracking - Sta. 5+00<sup>+</sup> - length 40 ft. Near crest of embankment.

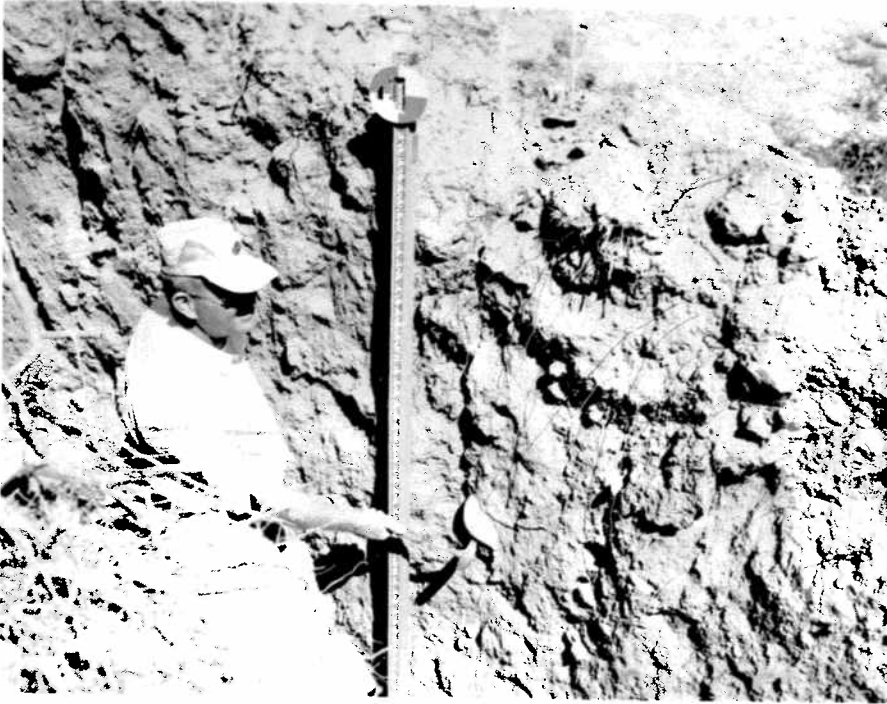
7. Profile of longitudinal crack Sta. 5+00<sup>+</sup>. Depth approx. 3'-0". Length 40'.

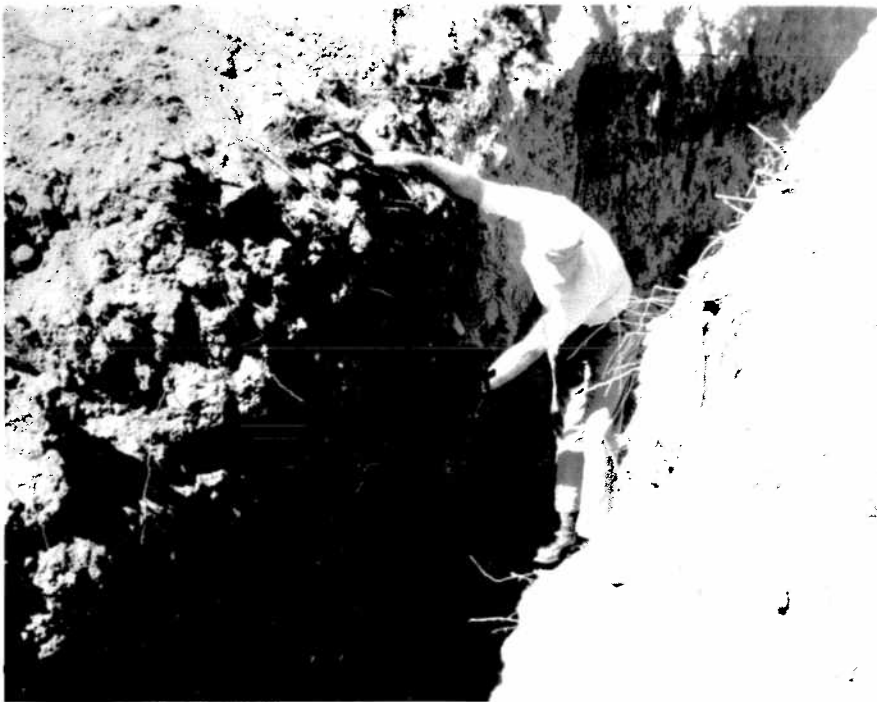
8. Trench excavated through U.S. slope Sta. 3+00<sup>+</sup>. Note delineated saturation line with very loose above and sl. consolidated below.
