Allen Reservoir Failure Analysis Docs

REPORT OF INVESTIGATION OF STRUCTURAL FAILURE

PROJECT and STATE: **Failure Investigation Allen Dam**

Allen Dam, Graham County, Arizona

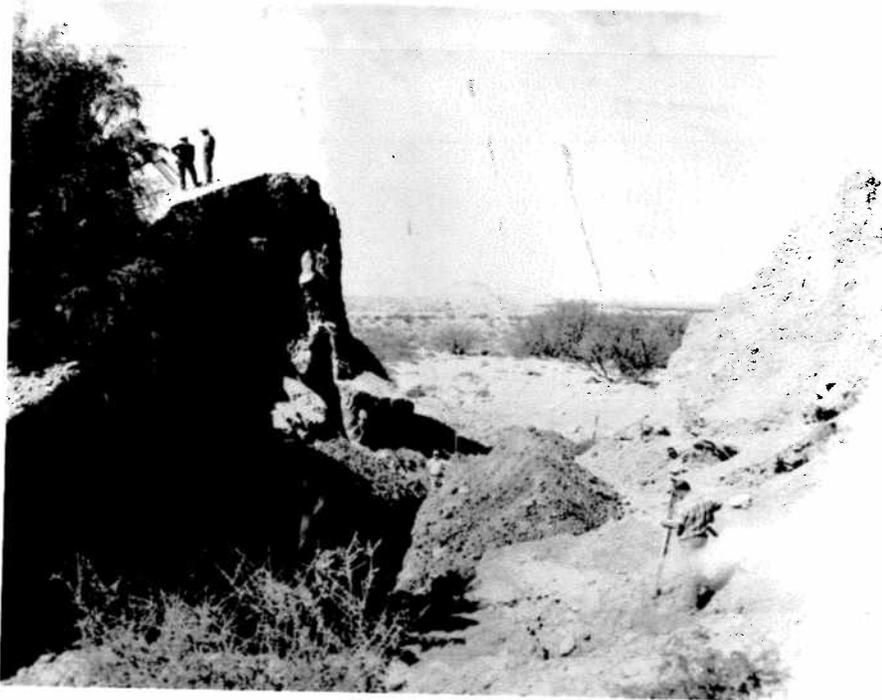
1. Looking northwest through washout - Sta. 2+50 \pm .

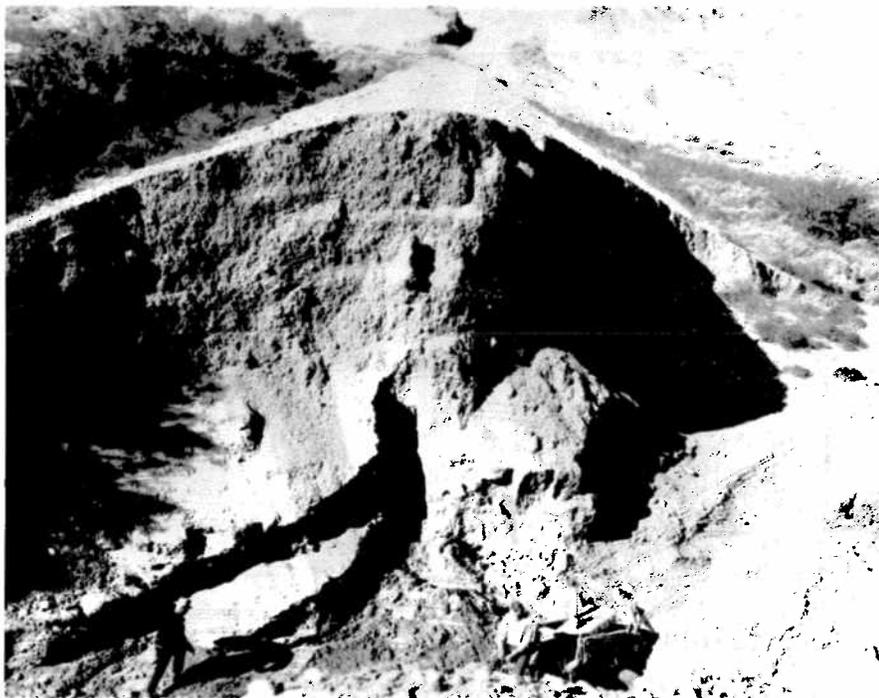
2. Looking west facing failure section Sta. 2+00 \pm .

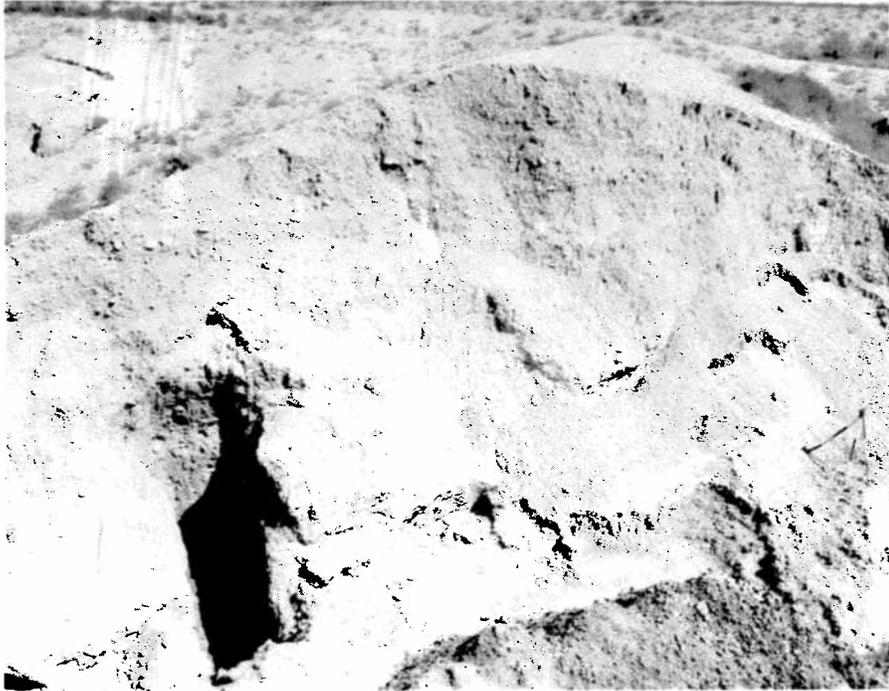
A backhoe pit was excavated in each face of the breach. The material excavated ranged from relatively clean gravels to quite plastic clays. (See photo #3). The moisture content varied from dry to approaching saturation. (See photo #8).

3. Looking east face Sta. 3+00±.

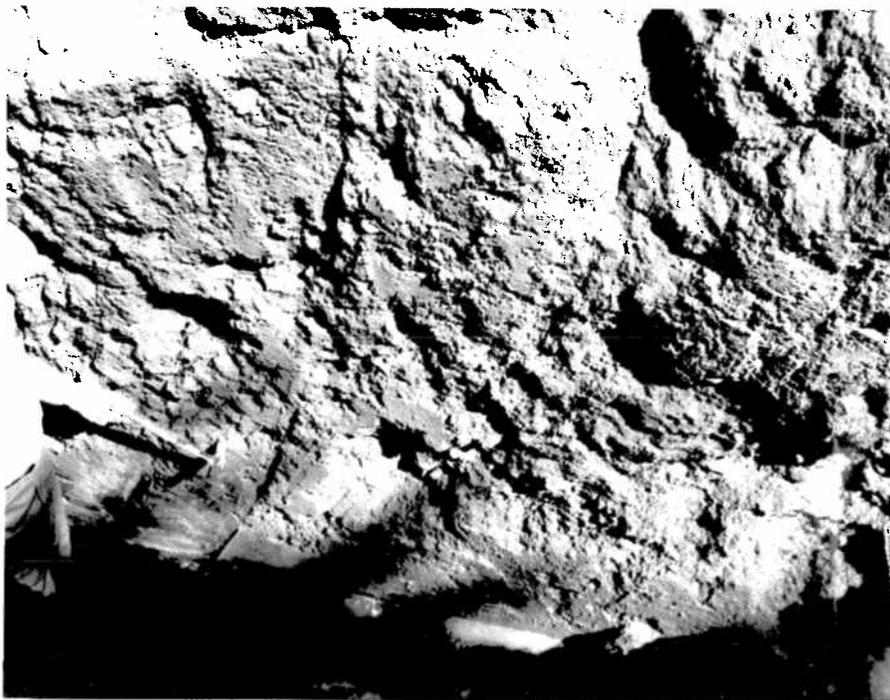
4. Foundation trench through failure section. Note contact of cutoff, gravel layer, and lake bed sediments.

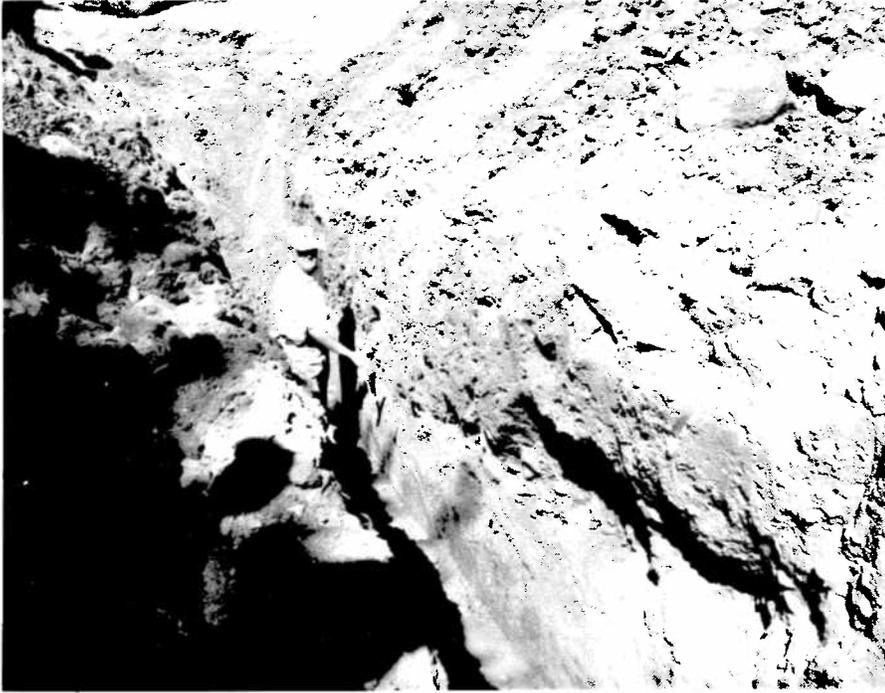
5. Foundation trench through failure section. Note base of cutoff by W. F. Mildner, Geologist.

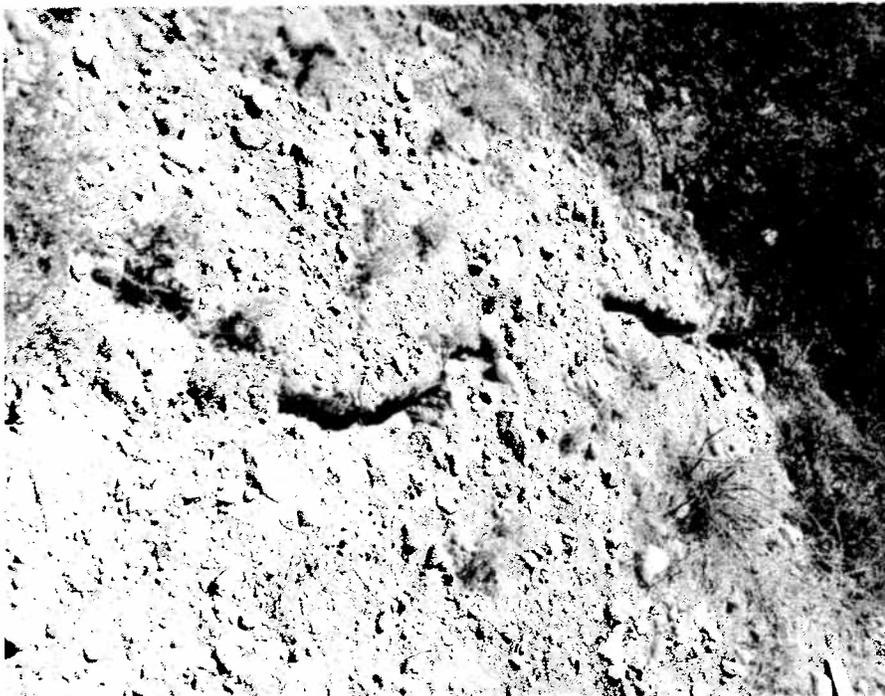
A longitudinal crack up to 3" or 4" in width was observed along the upstream face of the dam at about elevation 102. It started about 200 feet from the breach toward the left abutment and ran for about 40 feet. A backhoe pit was excavated across the crack. It went to a depth of about 3 feet. (See photos 6 and 7).

6. Longitudinal cracking - Sta. 5+00⁺ - length 40 ft. Near crest of embankment.

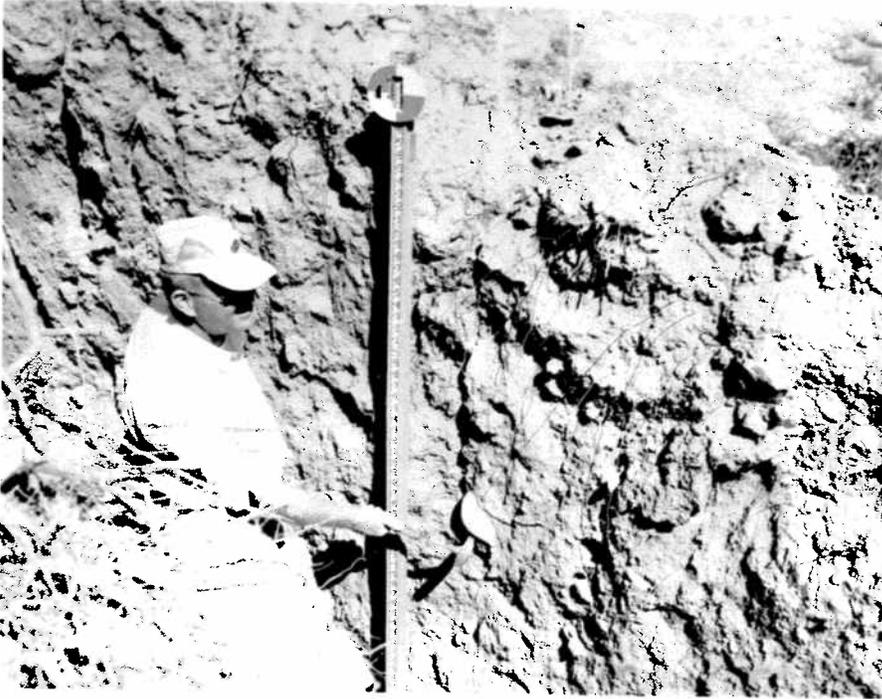
7. Profile of longitudinal crack Sta. 5+00⁺. Depth approx. 3'-0". Length 40'.

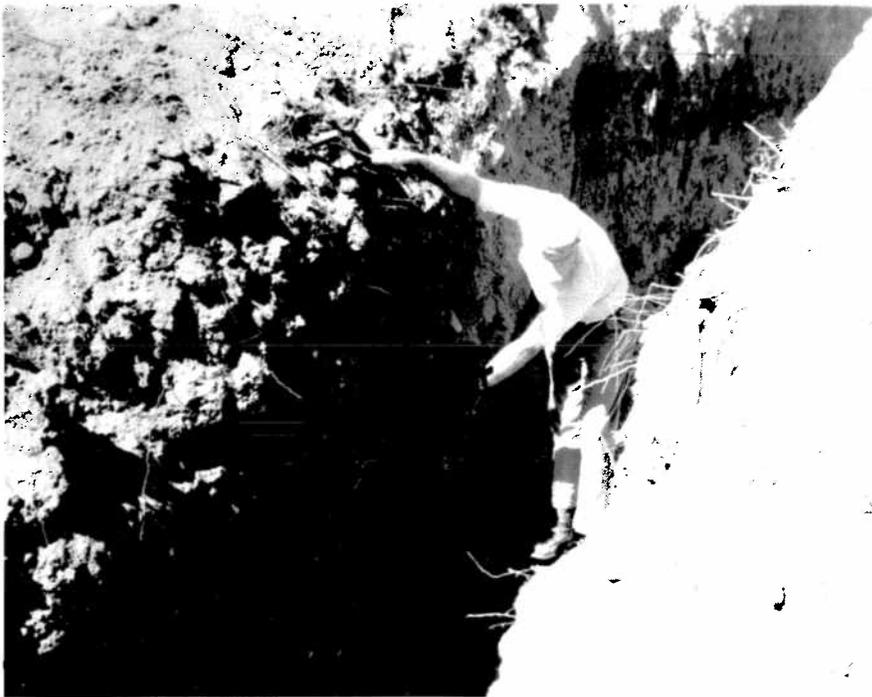
8. Trench excavated through U.S. slope Sta. 3+00⁺. Note delineated saturation line with very loose above and sl. consolidated below.
