Some Freeman Canal Preliminary Field Notes

Don Lancaster and **Dr. James Neely**

Preliminary discovery reveals the Freeman Canal and its apparently quite small nursery destination to presently range from **N 32.80004 W 109.75027** east to **N 32.80000 W 109.74991**, a distance of a mere 60 meters at elevations which approximate 3040 feet...

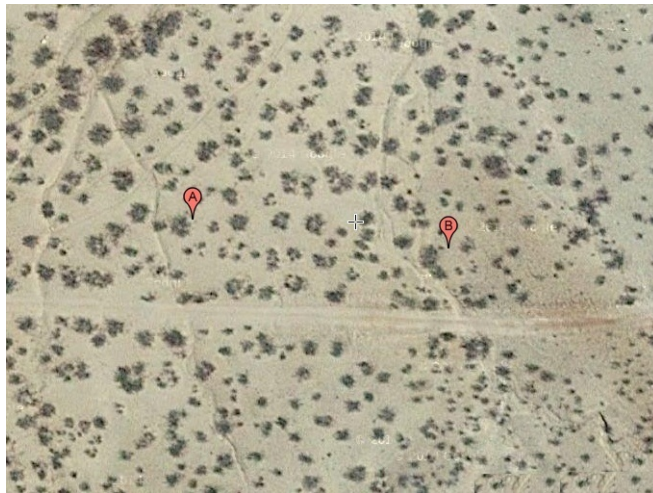
The canal is quite easy to visit, both on foot and with 4WD access west of the Porter Springs Road. It appears fragmented and disjointed with many significant portions still unresolved. The destination seems to be a small nursery located in a conspicuously rocky area in otherwise flat sandy desert. This would appear to be one of the very few canals in the bajada system that presently has an apparently known and well defined destination. Any such appearance is conspicuously absent in **Acme Mapper**.

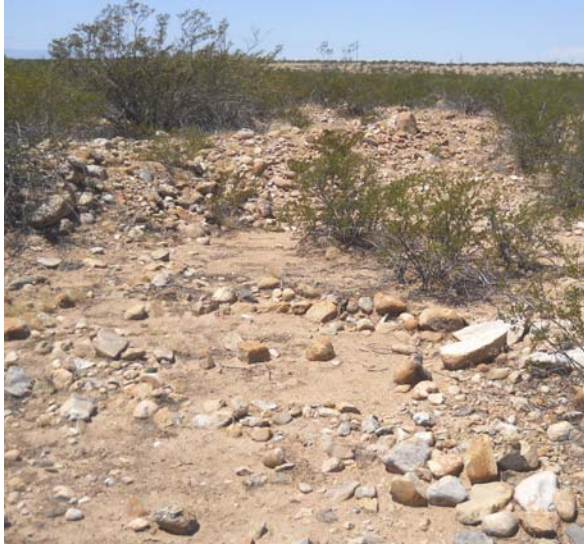
FREEMAN1 – Rock checkdams or nursery field boundaries. These are also quite common further south, but without a canal feeder and with aprons. Purposeful rock alignments can also be seen, presumably with intended ag purposes. View is to the west near **N 32.80001 W 109.74994**.

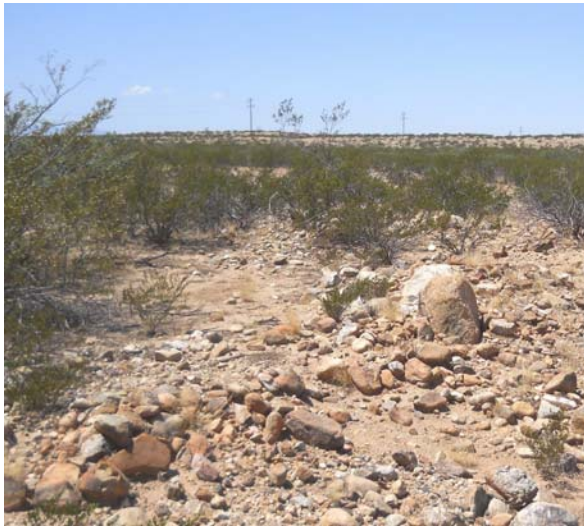
FREEMAN2 – Canal spoil pile boundary edges are somewhat erratic and rather jumbled in places, but there is reasonable evidence that they are in fact traceable canals. The view is to the east near **N 32.80002 W 109.74999**.

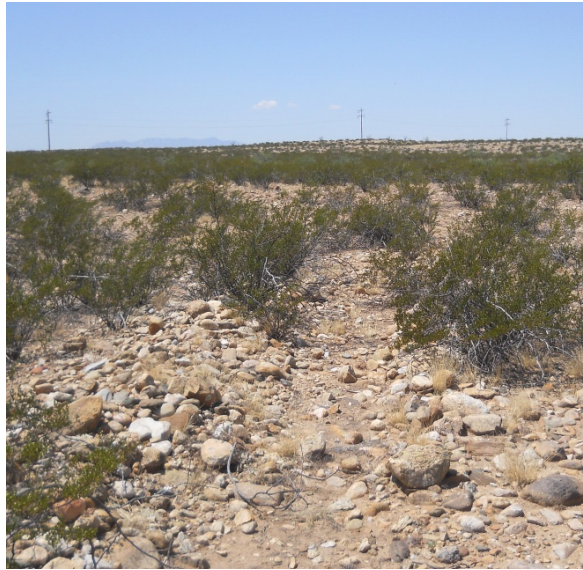
FREEMAN3 – Canal spoil banks remain erratic but are somewhat better defined in this image. Canal is 800 cm wide. View is east near **N 32.80003 W 109.75001**.

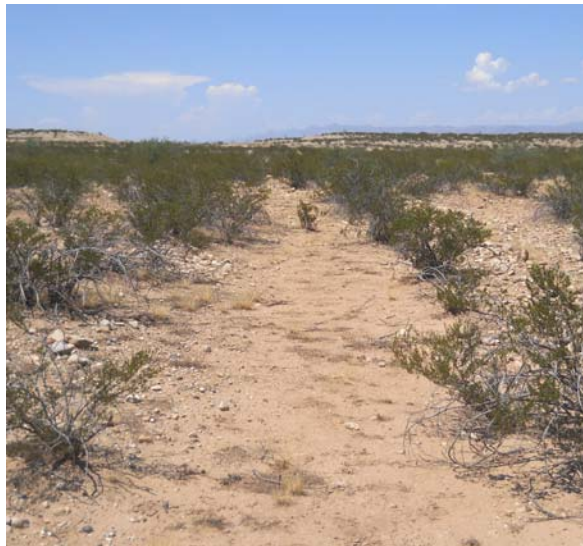
FREEMAN4 – The canal widens somewhat at this point and the required constant slope becomes much more apparent. View is west near **N 32.80002 W 109.75011**.

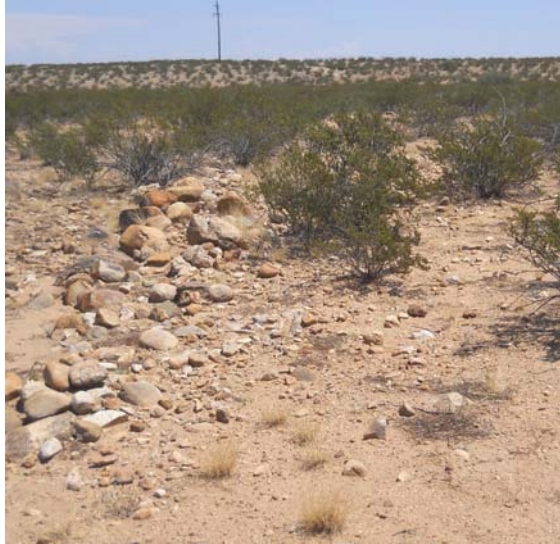
FREEMAN6 – Yet another view of non-uniform and erratic spoil banks. The view is to the east at **N 32.83154 W 109.92477**

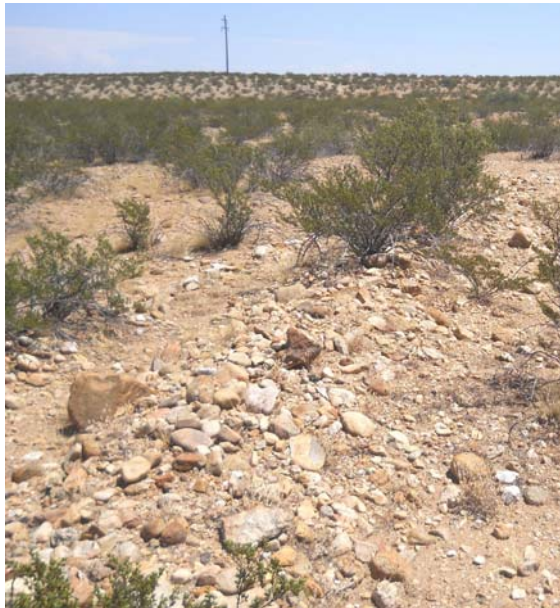
FREEMAN7 – The need for extreme energy efficiency on construction will overwhelmingly dominate on level terrain. Hanging portions are only used when slope must be made independent of terrain. The view is to the east near **N 32.80005 W 109.75013**.

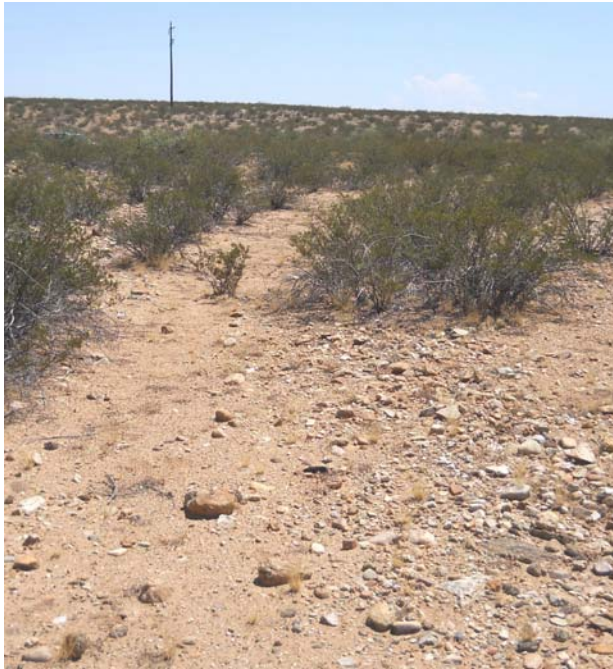
FREEMAN8 – A reverse view of **FREEMAN4**. Canal is broader and shallower in this reach and appears to have an aeolian fill. View is **N 32.80002 W 109.75011**.

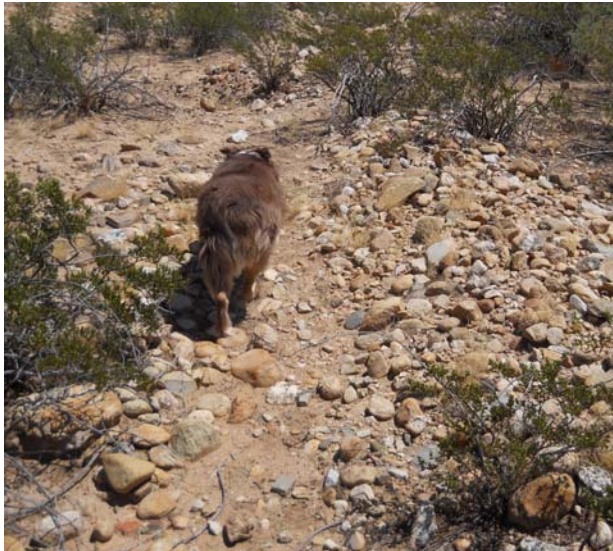
FREEMAN9 – Sally is a medium sized Australian Shepard who can add scale to the canal sizing. The view is east near **N 32.80004 W 109.75017**.
