REPORT OF INVESTIGATION OF STRUCTURAL FAILURE

**Structure Name and Location:** Allen Dam, approximately 2 miles SW of  
Thatcher, Graham County, Arizona  
(Sec. 9, T7S, R25E, Gila and Salt River  
Meridian)

Allen Dam, Graham County, Arizona

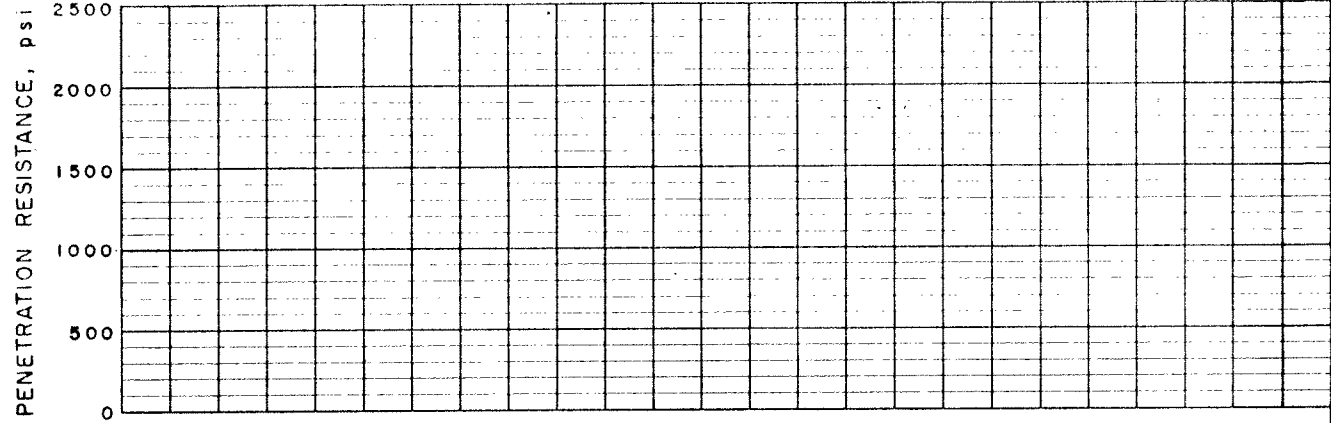
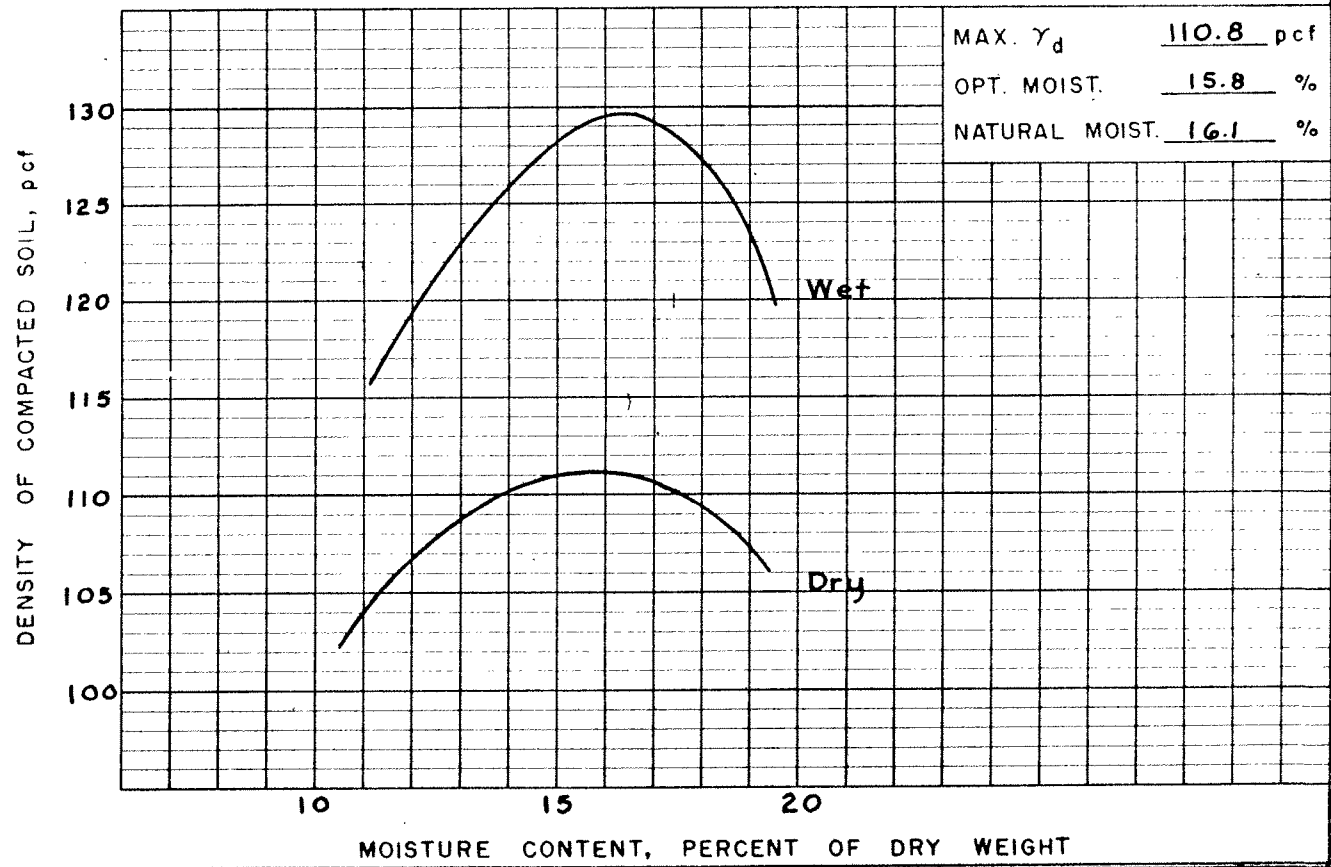
<b>MATERIALS TESTING REPORT</b>	U. S. DEPARTMENT of AGRICULTURE <b>SOIL CONSERVATION SERVICE</b>	<b>COMPACTION AND PENETRATION RESISTANCE</b>
---------------------------------	---	--

PROJECT and STATE: **Failure Investigation Allen Dam**
