Some Cluff Northwest Canal Preliminary Field Notes

Don Lancaster and Dr. James Neely

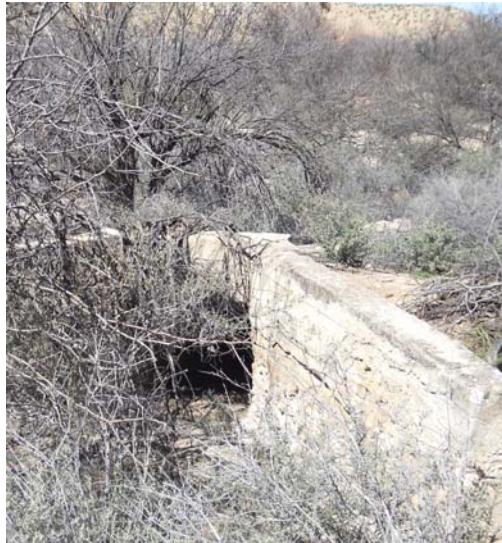
CLUFFNW1 – One of several **Y-Weir** concrete structures from the second historical rebuild of the Cluff NW canals. This one was apparently part of a wash crossing inverted siphon. Viewed northwest from **N 32.82647 W 109.84590**.

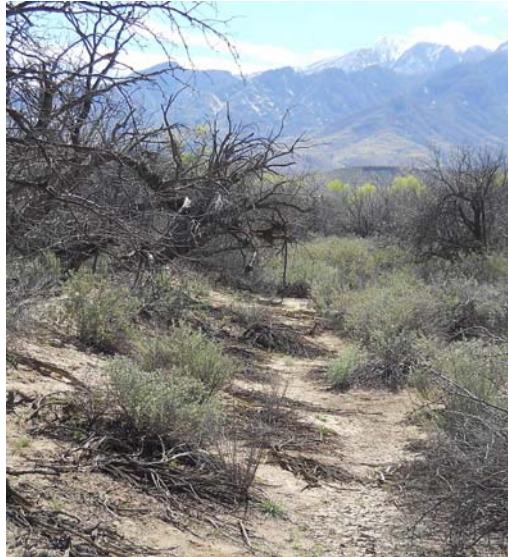
CLUFFNW2 – The second historic rebuild created a huge water channel whose size suggests **Gradall** class machinery and high construction energy inefficiency. Portions are unusually single walled. View is south at **N 32.82625 W 109.84596**.

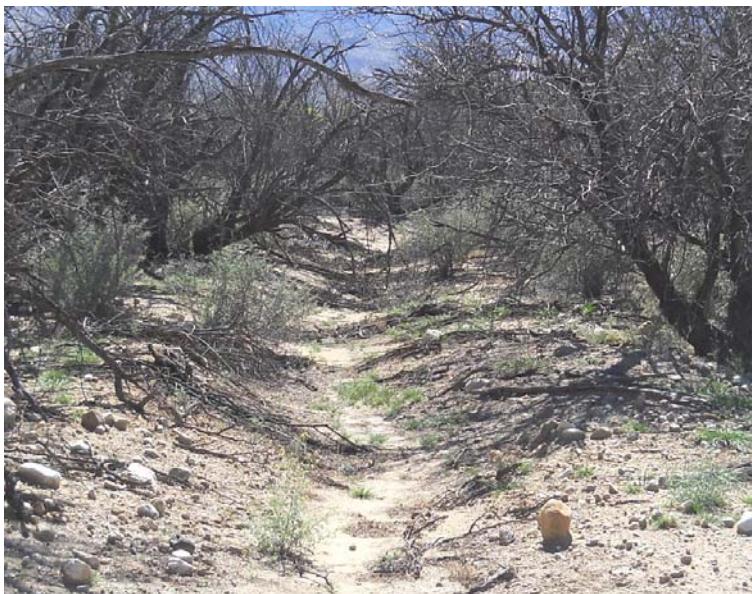
CLUFFNW3 –The small size, stone tool compatibility, and its extreme energy efficiency strongly suggests adaption of a prehistoric origin for this canal segment. View is south from **N 32.81908 W 109.84566**.

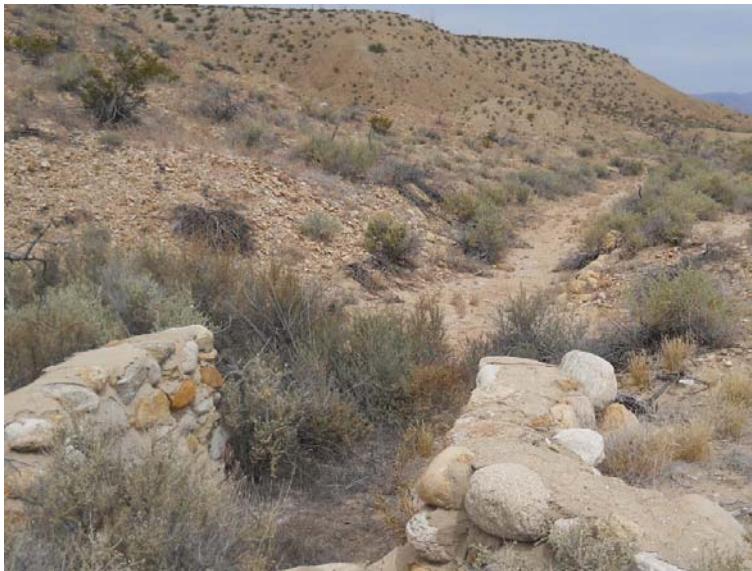
CLUFFNW4 – An additional example of a Y-Weir on the second historic canal rebuild. The purpose seems to be an erosion proof foot high dam. The view here is to the north near **N 32.83044 W 109.84473**.

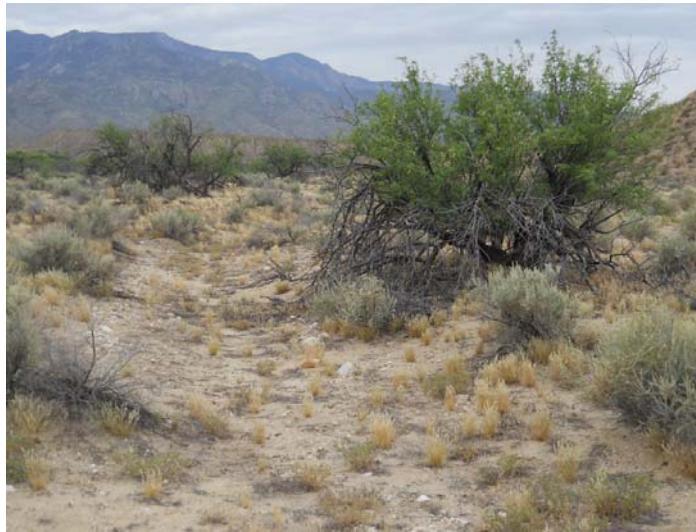
CLUFFNW5 –This reach appears to be a prehistoric original, with the historic rebuilds separate to the south and west. Again, the small size, its stone tool compatibility, and high energy efficiency strongly suggest ancient origins. The view is to the south at **N 32.82879 W 109.84500**.

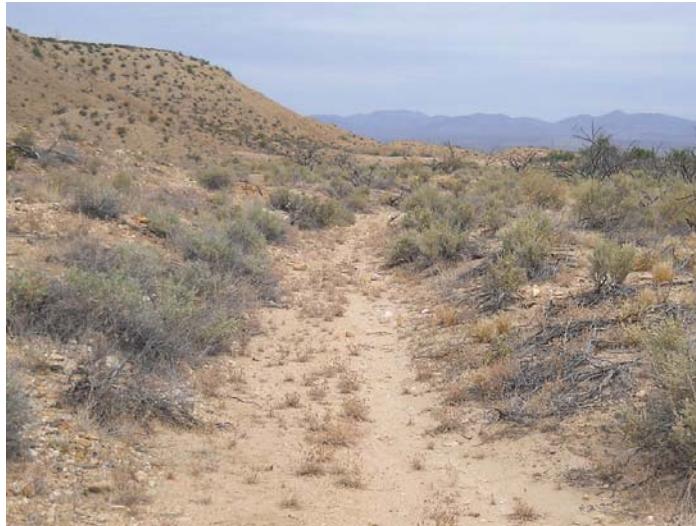
CLUFFNW6 – Downstream portion of historic rebuild extends quite a distance to a group of cardinal rectangular fields rather obvious on [Acme Mapper](#). The view here is to the north near **N 32.83045 W 109.84474**.

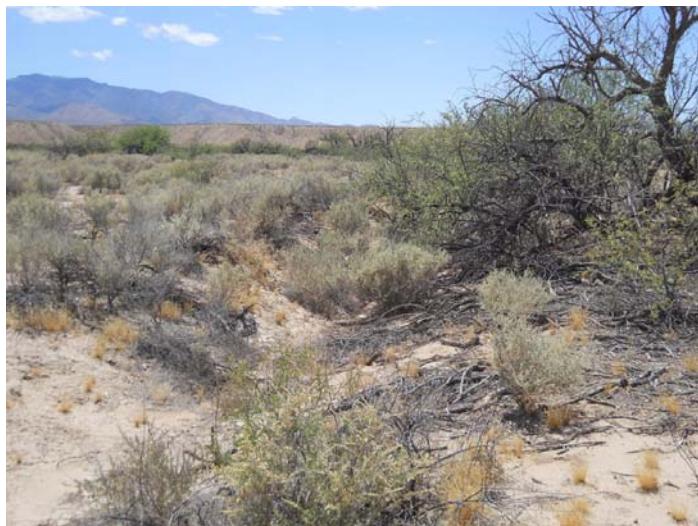
CLUFFNW7 –The small size, stone tool compatibility, and the extreme energy efficiency strongly suggests adaption of a prehistoric origin for this canal segment. View is south from **N 32.81908 W 109.84566**.

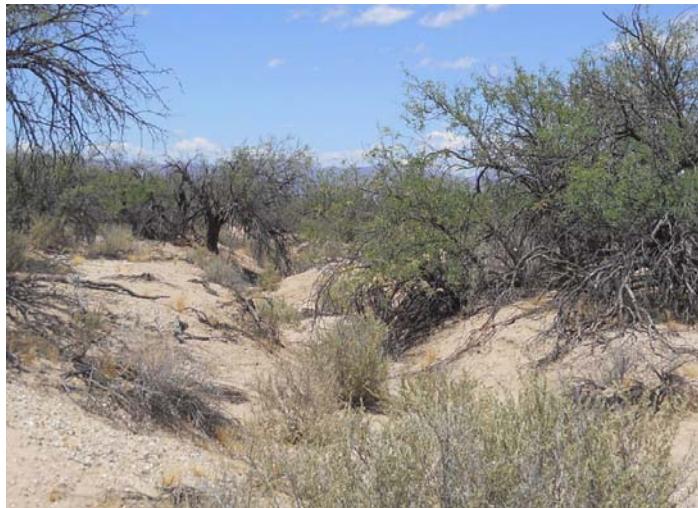
CLUFFNW8 – Yet another view of an apparently early historic revision to the original channel. The view here is to the north at the road crossing found near **N 32.82512 W 109.84810**.
